Failure Analysis of Short Faults on Advanced Wire-bond and Flip-chip Packages with Scanning SQUID Microscopy

Steve K. Hsiung, Kevan V. Tan, Andrew J. Komrowski, Daniel J. D. Sullivan
LSI Logic Corporation, 3098 West Warren Avenue, Fremont, California 94539
Tel: 408-433-8838 Fax: 408-433-8892 Email: stevehs@lsil.com

Abstract

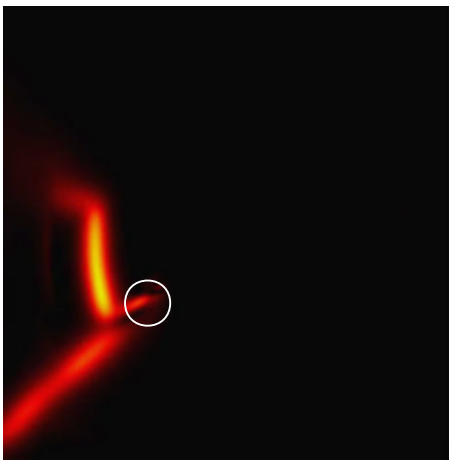
The device was then analyzed by SSM. The SSM current density image (Figure 4) and current peak image (Figure 5) were obtained. The current density image was then overlaid to the bonding diagram (Figure 6). The short is on the die side (Figure 7).

Figure 4 SSM current density image

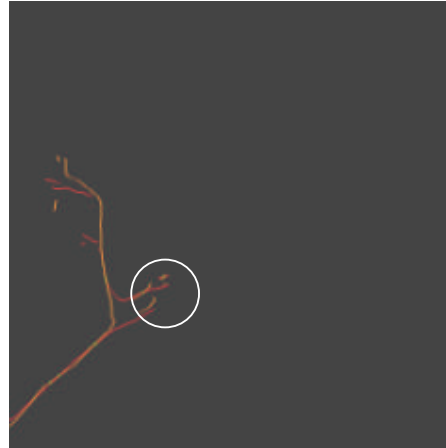
Figure 5 SSM current peak image

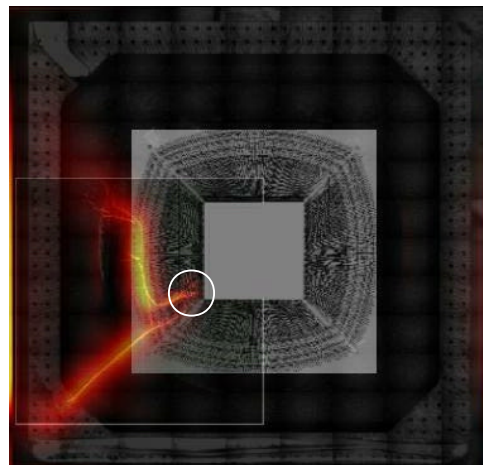
Figure 7 SSM current density image overlaying CAD file

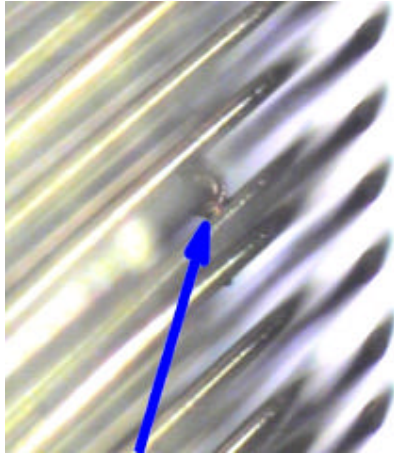
The device was then chemically decapped on the die surface. Visual inspection revealed a partially lifted ball bond from one failing I/O pin contacting the bond wire of

the other failing I/O pin (Figure 8). The short went away after the ball bond was pushed away.

Figure 8 Optical image of the lifted ball bond of one failing I/O pin that was touching the bond wire of the other failing I/O pin

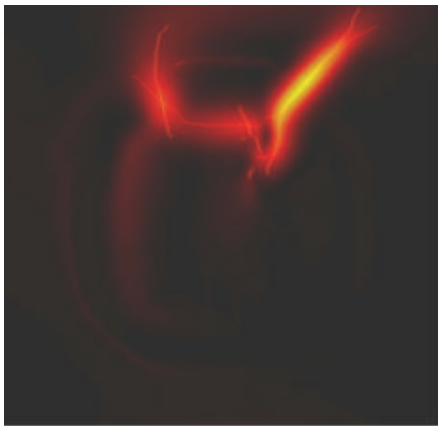
The SSM current peak image (Figure 9) overlaid with the bonding diagram pinpointed the short to bond wires close to the power ring (Figure 10).

Figure 9 SSM current density/peak image

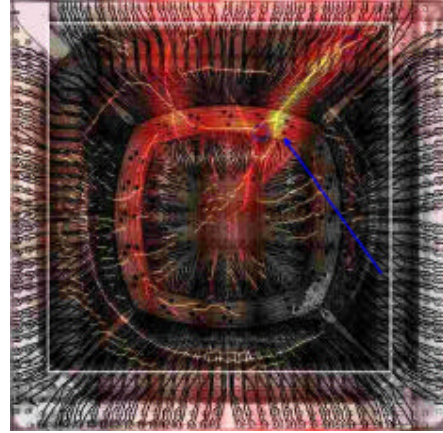
Figure 10 SSM current peak image overlaid with bonding diagram pinpointing shorts to bond wires close to the power ring

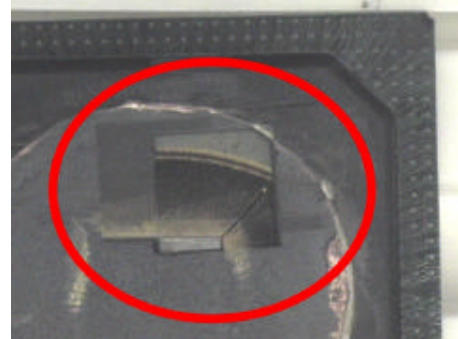
Chemical decapsulation to expose bond wires is risky, because it often results in overetching. Employing a laser decapsulation tool, the mold compound was selectively removed at the target area, exposing the entire bond wire loop (Figure 11).

Figure 11 Optical image of the device where mold compound was partially removed by a laser decapsulation tool

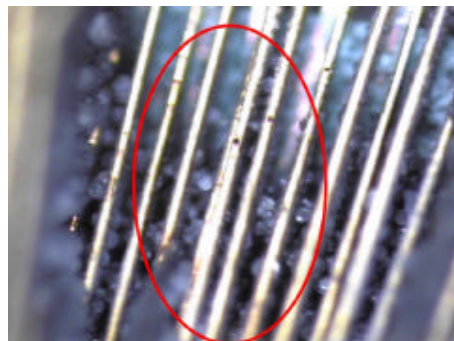
Based on SSM data, visual inspection was focused at the VSS power ring. Two bond wires were observed to be shorting close to the power ring (Figure 12). The short disappeared after the two bond wires were separated.

Figure 12 Optical image of two shorted bond wires in the area indicated by SSM data

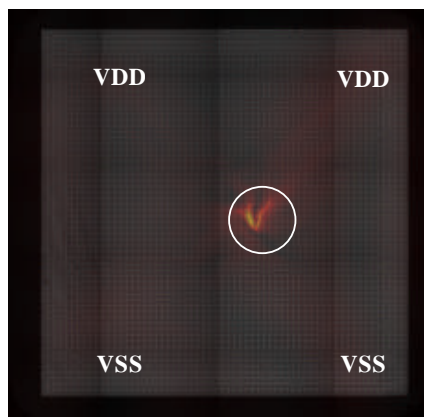
Two VDD pins on top left and right corners and two VSS pins on bottom left and right corners were connected. The current was set less than 2 μ A. The device was scanned. The SSM current density image overlaid IR image shows a spot with strong current density (Figure 16).

Figure 16 SSM current density image overlaid IR image shows a spot with strong current density using one set of VDD and VSS pins

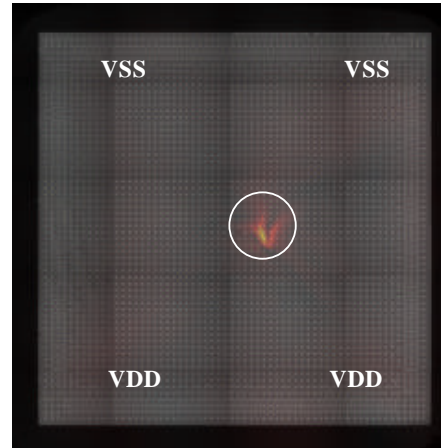
Next, two different VDD pins and two different VSS pins were connected. The device was scanned again. The SSM current image overlaid IR image pinpoints to the same location with strong current density (Figure 17).

Figure 17 SSM current density image overlaid IR image shows a spot with strong current density when powered by a different set of VDD and VSS pins

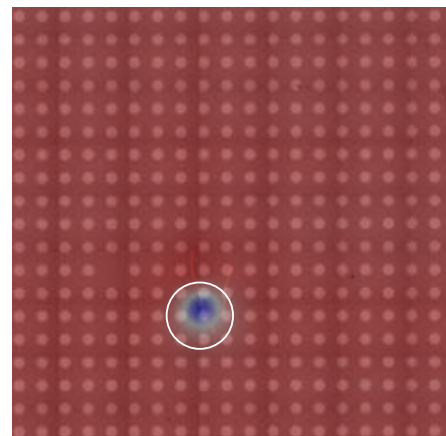
The DC static magnetic field image revealed a dipole in that spot that suggests there might be a magnetic material such as Iron, Nickel or Cobalt at this location (Figure 18).

Figure 18 SSM peak current image overlaid DC static magnetic field image revealed a magnetic dipole in that spot

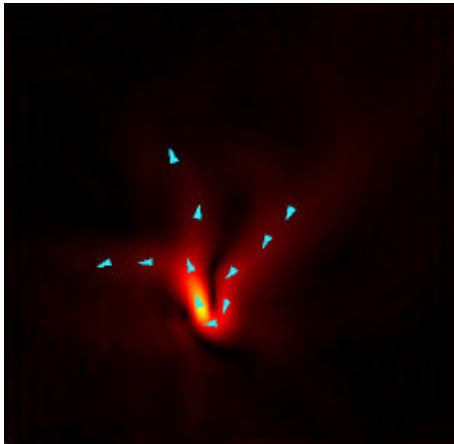
The current peak image overlaid with the IR image in high resolution indicates the short fault is in interconnect solder bumps, not in the package substrate. This is identified by tracing the current path; the current is observed to be closer to the surface in the region of the short than the current flow in other parts of the package (the current density peak is largest close to the SQUID sensor). This yields the Z position of the fault.

Figure 19 The SSM current peak image in high resolution indicates the short is in the interconnect solder bumps

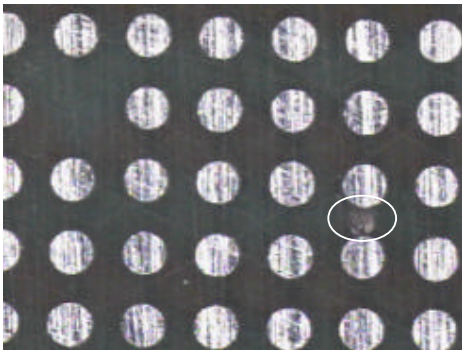
The die was removed by mechanical grinding. Visual inspection revealed an anomaly at the location identified by SSM (Figure 20). Parallel-lapping the solder bumps revealed a particle trapped between solder bumps of VDD and VSS in the underfill material (Figure 21). EDX analysis identified the particle to be composed of Fe (Iron), Ni (Nickel) and Cr (Chromium) (Figure 22). The stainless steel particle confirms the SSM data analysis.

Figure 20 Optical image of an anomaly in the location identified by the SSM

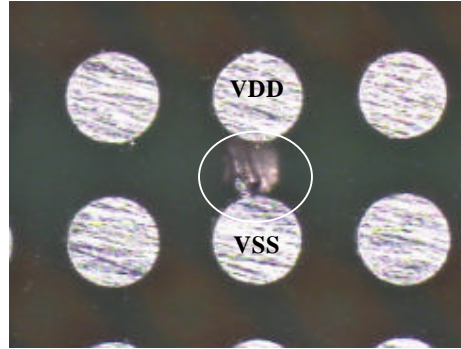
Figure 21 Optical image of a particle trapped between solder bumps of VDD Core and VSS Core in underfill material

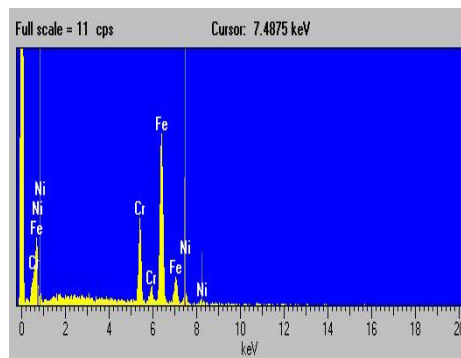
Figure 22 EDX spectrum of the particle that shows the elements of Fe (Iron), Ni (Nickel) and Cr (chromium)

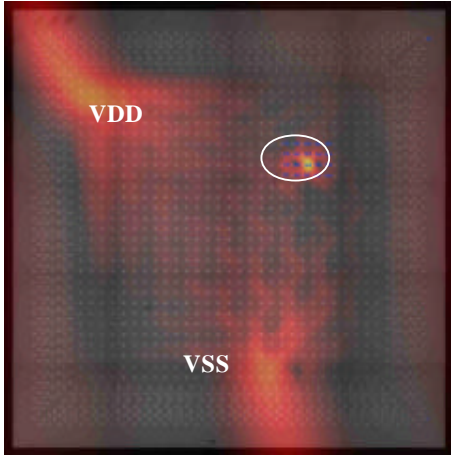
The first scan was taken with a VDD pin on top left corner and a VSS pin on bottom center connected. The second scan was done with a VDD pin on top right corner and a VSS pin on center left connected. The current was set less than 2 μ A. Both scans generated images with strong current density at the same location (Figure 23 and Figure 24). This is the X-Y position of the short fault.

Figure 23 SSM current density image overlaid IR image shows a location with strong current density

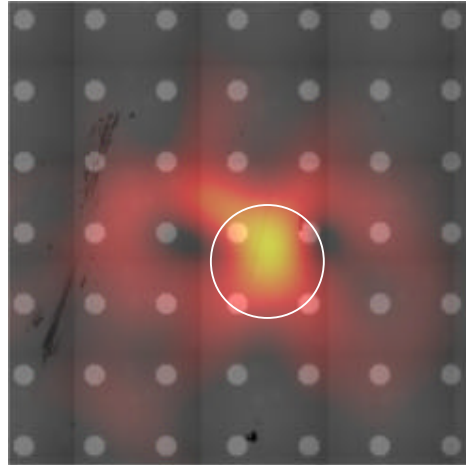
Figure 25 SSM current density image overlaid IR image in high resolution

The current density image overlaid IR image in high resolution did not show very obvious sign of the Z-position of the fault. The current density was diffuse. There was also no magnetic dipole observed in that location (Figure 25).

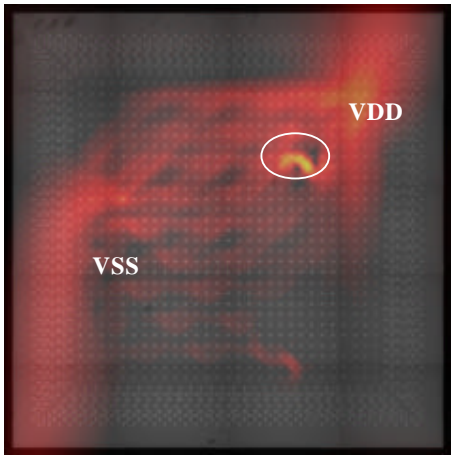
Figure 24 SSM current density image overlaid IR image shows the same location with strong current density even when different VDD and VSS pins were connected

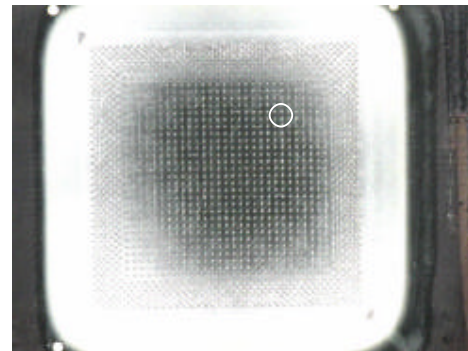
After the die was removed by mechanical grinding (Figure 26) and the underfill material was removed by plasma ashing (Figure 27), the resistance remained the same at 1.7 K Ω . This confirms the SSM data analysis -- the short occurred in the package substrate. A defect was found at the location identified by SSM in the substrate after sequential parallel-lapping and cross-section.

Figure 26 Optical image of the device after die was removed by mechanical grinding

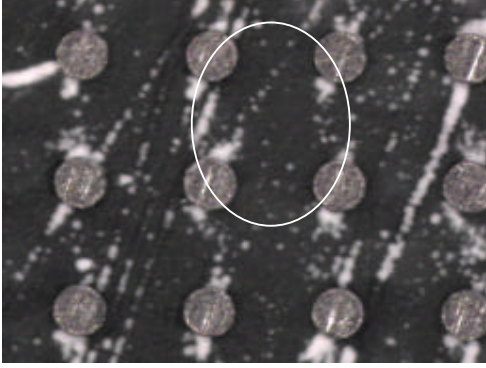
Figure 27 Optical image in high resolution of the location after underfill material was dissolved by plasma ashing
