Failure Analysis on Resistive Opens with Scanning SQUID Microscopy

J. Gaudestad, A. Orozco, E.Talanova, L.A. Knauss

S. K. Hsiung, K. V. Tan, A. J. Komrowski, D. J. D. Sullivan

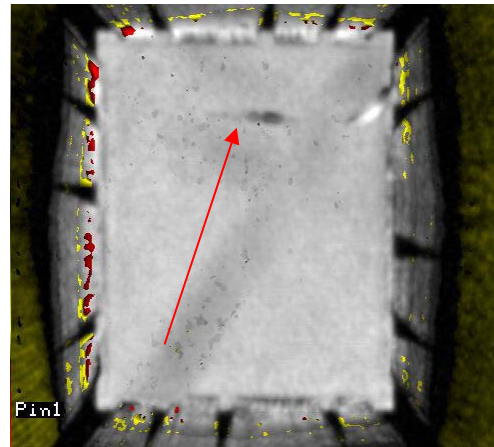
Acoustic Microscope in C-Mode (C-SAM) analysis shows a possible die crack on the die surface (Figure 2).

Figure 2 C-SAM image of a possible die crack on the die surface

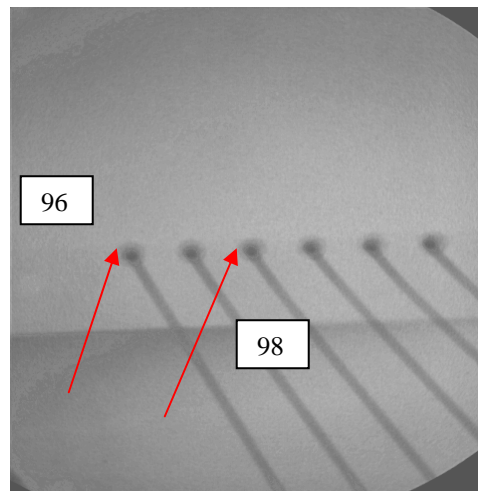
Figure 3 X-ray image of the ball bond of the failing pin# 96 and pin# 98 no anomalies observed.

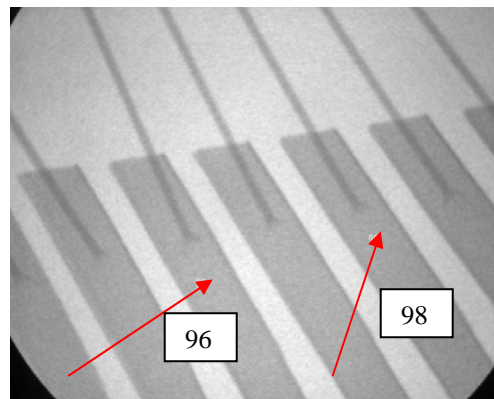
Figure 4 X-ray image of stitch bond of the failing pin#96 and pin#98 no anomalies observed.

Real-time X-ray Inspection observed no anomalies, so an alternative non-destructive approach-using SSM analysis was employed.

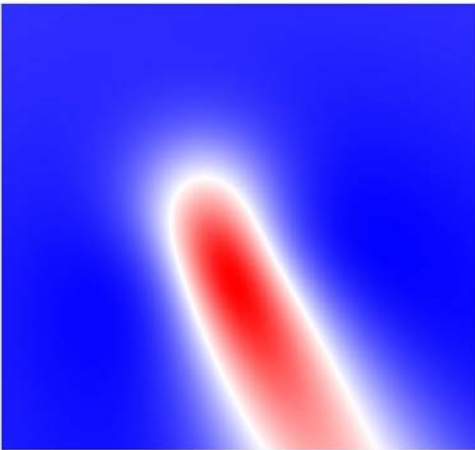
The magnetic-field images picked up by SQUID from the failing and good parts contain only subtle differences (Figure 5 and Figure 6).

Figure 5 The magnetic-density image of Pin #96 and Pin#98 from the failing part

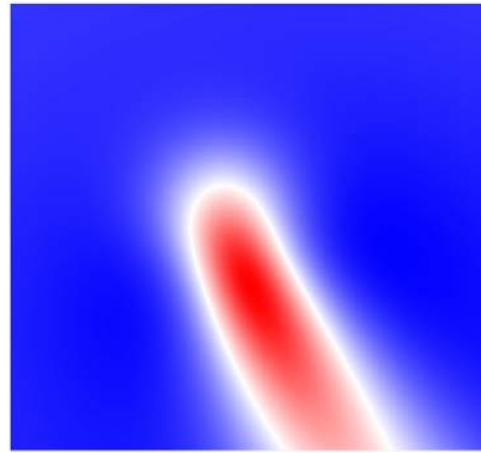
Figure 6 The magnetic-density image of Pin #96 and Pin#98 from the good part.

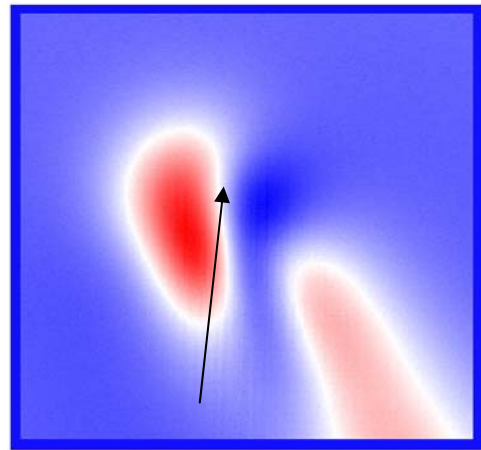
IDA-Image-processing algorithms are able to optimize the magnetic field comparison of good and failing parts and extract the magnetic anomaly (dipole). The software computes the centroid of the anomaly pointing to the most likely resistive open location (Figure 7 and Figure 8).

Figure 7 IDA optimized magnetic field comparison showing dipole. The centroid of it is the defect location.

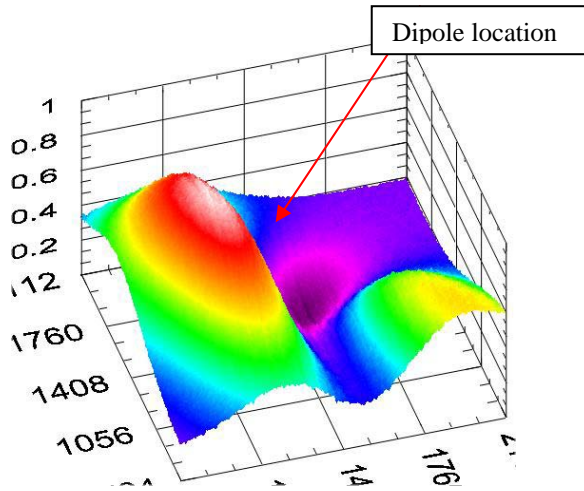
Figure 8 3D of view of IDA residual anomaly

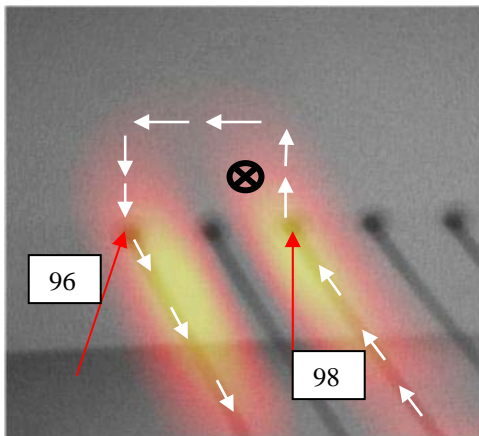
Figure 9 The current-density image overlaid to X-ray image indicates that the resistive open occurred near Pin#98. Also shown is the current path and direction.

SSM analysis showed that the resistive open occurred within the die metallization, specifically pinpointing the defect to pin #98 prior to any destructive deprocessing.

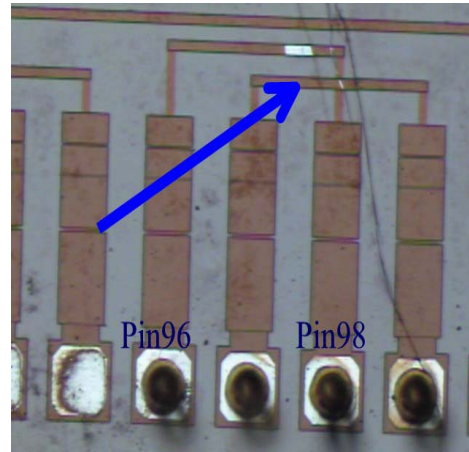
In order to visually inspect the die surface, the remaining encapsulant was removed with fuming Sulfuric Acid. Optical inspection showed a crack crossing the die surface that broke the top metalization between daisy-chain pair #96-98. The failing area is near Pin#98, confirming what the SSM reported (Figure 10).

Figure 10 Optical image of die crack that broke the top metalization

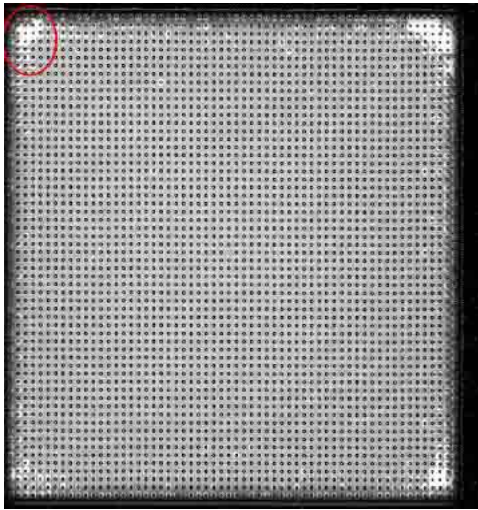
Acoustic Microscope in C-Mode (C-SAM) analysis showed corner delamination and/or voiding at the die-underfill interface (Figure 11).

Figure 11 C-SAM image of corner delamination/void at the die-underfill interface. The failing area is indicated with a circle. Corner delamination and/or voiding was seen in all four corners, but the failing pins were confined to only one corner. Time Domain Reflectometry (TDR) analysis was performed to characterize the discontinuity (Figure 12 and Figure 13).

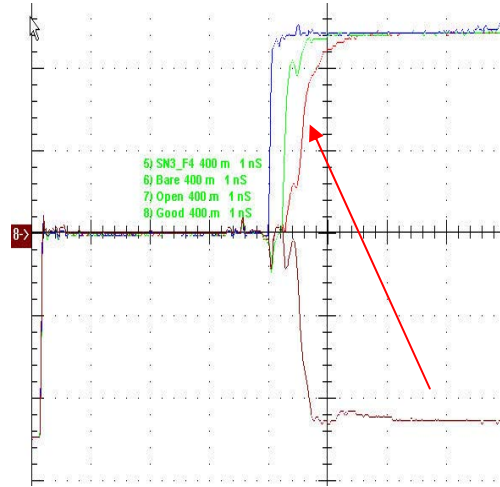
Figure 13 TDR waveforms of pin F4 that indicates it was open in the interconnect solder bump

The TDR waveforms characterized the resistive opens to be in the interconnect solder bumps, but could not specify which solder bumps were failing. Therefore, SSM analysis was used to further localize the defect.

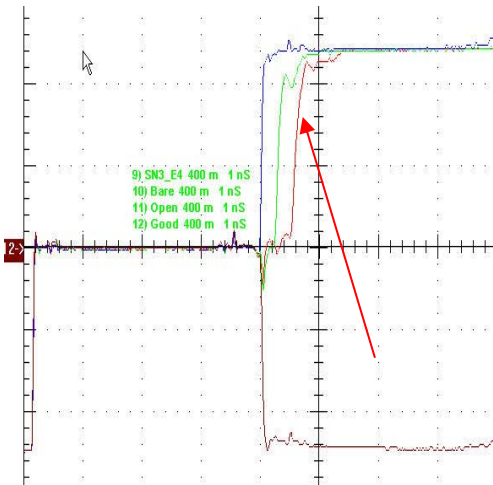
Figure 12 TDR waveforms of pin E4 that indicates it was open in the interconnect solder bump

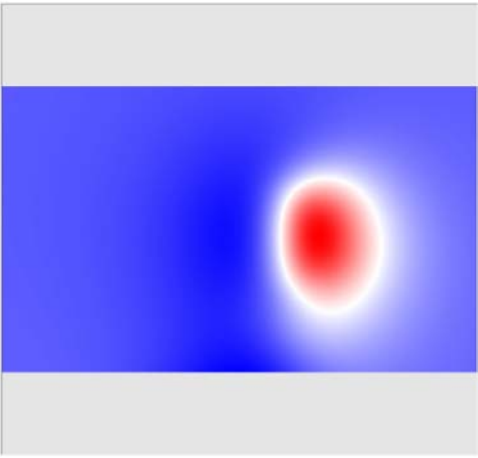
Figure 14 The magnetic images of pinE4 and pinF4 from the failing part

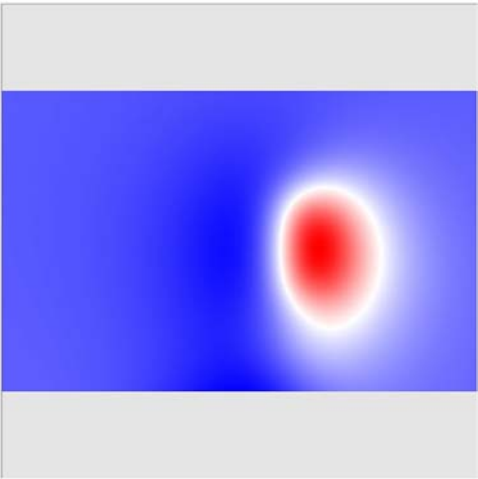
Figure 15 The magnetic images of pin E4 and pin F4 from the good part

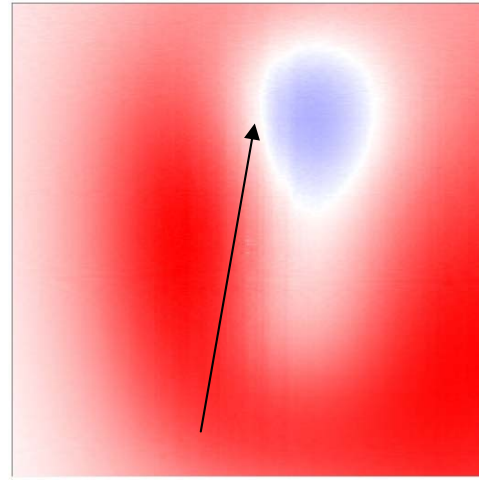
Again, IDA image-processing algorithms show a dipole. The center of the dipole is where the resistive open is located (Figure 16 and Figure 17).

Figure 16 IDA resulting image from the failing and good parts. The centroid of the dipole corresponds to the defect location.

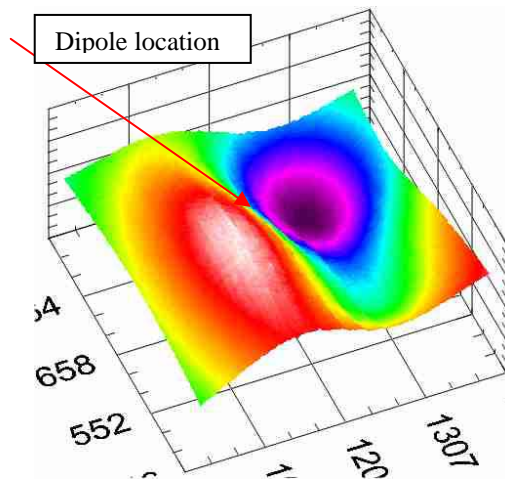
Figure 17 3D of the IDA magnetic field image

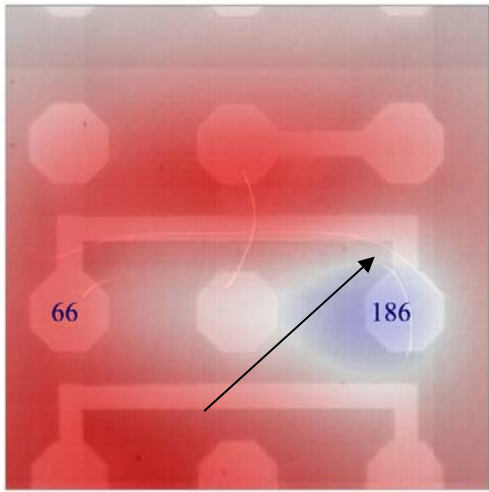
The peak image and the magnetic-field IDA image were overlaid with the high resolution IR image. The dipole is very close to the upper solder bump #186 of pin F4. This is the failing location (Figure 18).

Figure 18 The peak image and the magnetic image were overlaid to the high resolution IR image. The dipole marked with an X is the failing location. (The image has been rotated compared to Figure 16).

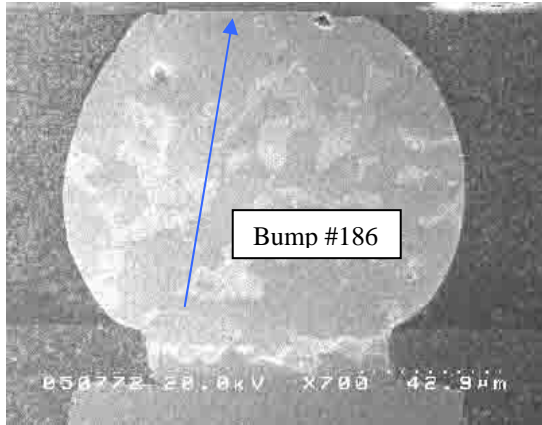
Mechanical cross-section through the solder bumps of pin E4 and pin F4 revealed a crack in the bump 186 of the pin F4. The crack was caused by solder bump fatigue due to the void at die-underfill interface (Figures 19 to 22). This verifies the SSM defect location.

Figure 19 SEM image of solder bump 186 of pin F4. The crack is indicated by an arrow

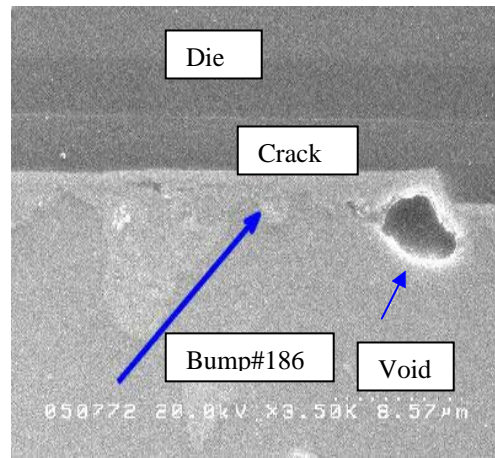
Figure 20 SEM image in high resolution of crack at die-underfill interface in the solder bump #186 of pin F4

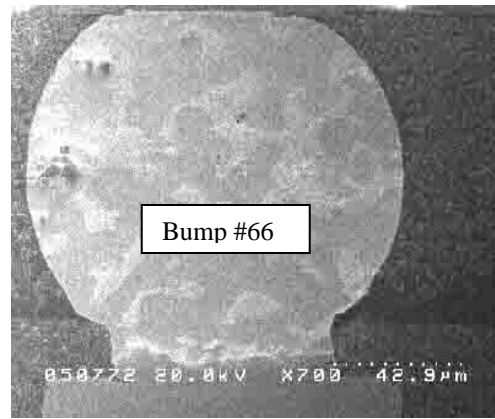
Figure 21 SEM image of good solder bump 66 of Pin E4, which is paired with pin E4

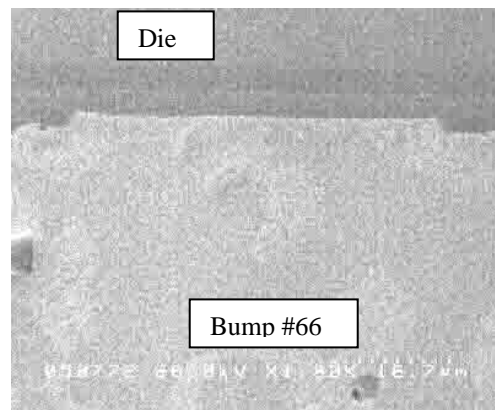
Figure 22 SEM image in high resolution shows good die-underfill interface in the solder bump 66 of pin E4
