Scanning SQUID Microscopy for Die Level Fault Isolation

David P. Vallett

IBM Microelectronics Division, Essex Junction, Vermont, USA

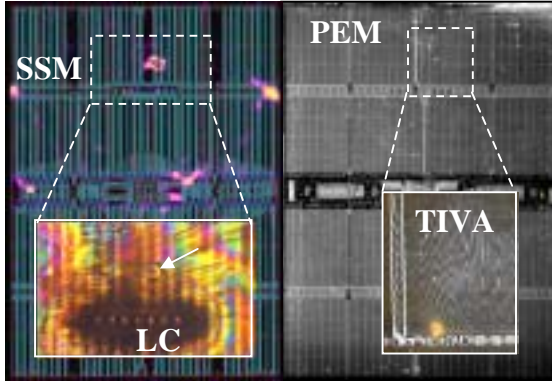
Figure 1: a) SSM and LC results for standby current failure on a 10x14 mm SRAM. b) PEM and TIVA images.

The device was scanned while in a surface mount socket on a tester interface board, biased at 130 mVAC_{pp} drawing 100 μ A (DC average power P_{eff}

= 6.4 μ W). The results are shown in Figure 1a, where the highlighted peak corresponds with the LC location observed from the frontside of the die prior to packaging, seen at the arrow in the inset. PEM analysis on the same device at 2.0 VDC with 200 mA, and TIVA at 5mA, are shown for comparison in Figure 1b.

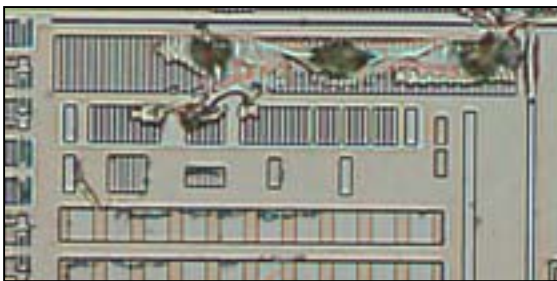
Figure 2: Optical image of typical NFET overload site at silicon level.

Power supply shorts on a 9 mm square, 0.16 micron L-drawn ASIC test site, caused by electrical overloads during burn-in, were found optically after etching to silicon level (frontside liquid crystal was unsuccessful). Figure 2 shows an optical image of a typical shorting site at silicon level in a 990 micron wide by 0.6 micron long NFET in a power supply isolation device. There are ten identical instances of the overload-sensitive circuit on the chip, outlined in Figure 3.

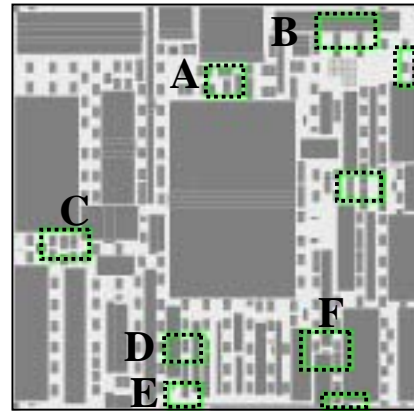
Figure 3: Locations of potential overload-sensitive circuits.

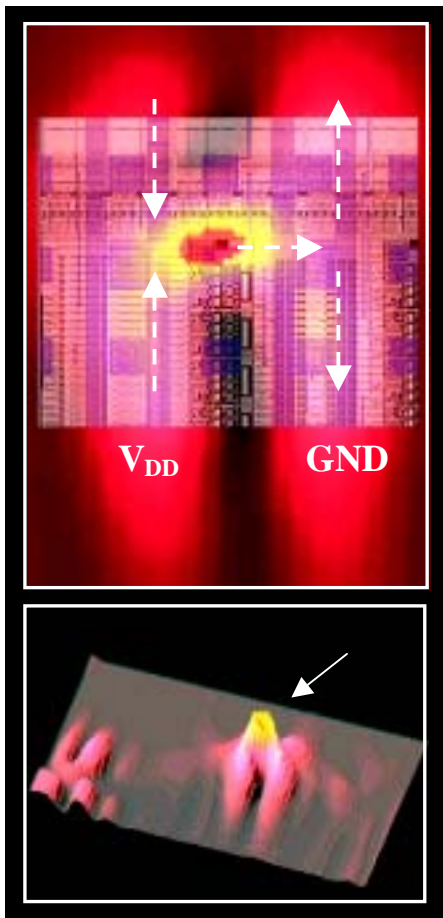
Figure 6: a) Magnified SSM image of fig. 4a site 'B', overlaid with CAD layout. Arrows indicate current paths. Vertical Vdd and GND traces are separated by about 540 microns. b) Surface plot of same site.

The prominent current density peak noted at location 'B' in Fig. 4a is shown magnified in Figure 6a, and overlaid with CAD layout data. The

arrows indicate current paths in the last metal power busses consistent with the polarity and intensity of the magnetic flux measured. A surface plot of the same peak is seen in Figure 6b, showing the peaked nature of the SSM signal and greater detail in the surrounding data.

Two distinct signatures are also evident in the data. The single strong peak and surrounding 'fingers' in Fig. 6, for example, are consistent with current converging to and diverging from a point between two conductors. The size scale and orientation of

the signature is also in agreement with the circuit layout shown in Fig. 6a. A second signature, the four-lobed signal in Fig.'s 7, 9, and 10, is also consistent qualitatively and dimensionally with current converging and diverging on orthogonal paths. The polarity of the magnetic flux in Fig. 9 was used to determine the direction of current. The flux concentration in this case is caused by the superposition of the gradients associated with the four current segments. Contributing to the four-lobed nature of the signature is the physically vertical component of the path seen in Fig. 11. A magnetically 'silent' area exists directly over such vertical segments because their corresponding magnetic flux is parallel to the horizontal SQUID, and therefore not detected by it.

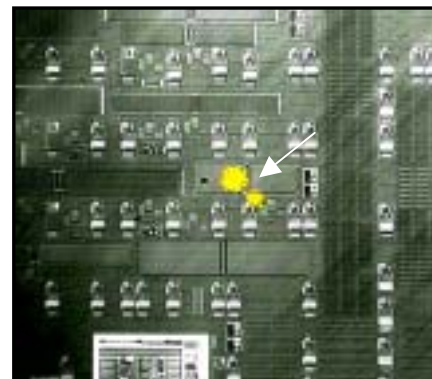
Figure 8: STM signal at area highlighted in fig. 7.

A 0.1 micron L-drawn, 9 mm square ASIC product with six levels of metal, failing for power supply shorts, was examined from the backside of a flip-chip CBGA package. The sample was biased with power and ground at 250 mVAC_{pp} and drew 6.5mA ($P_{avg} = 800 \mu W$) in a surface mounted socket on a tester interface card. The SSM signal is shown overlaid on a backside optical image in Figure 7. Corresponding STM data with the sample biased at 400 mV and 100 mA are shown in Figure 8 for comparison. Figure 9 shows the magnetic flux density from which the signal highlighted in Fig. 7b is derived.

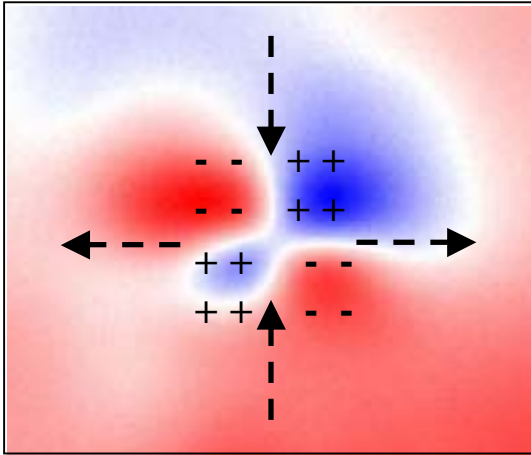
Figure 9: Magnetic flux density and polarity around SSM signal shown in figure 7b. Arrows indicate current flow based on right-hand rule, and consistent with layout in Fig. 10a.

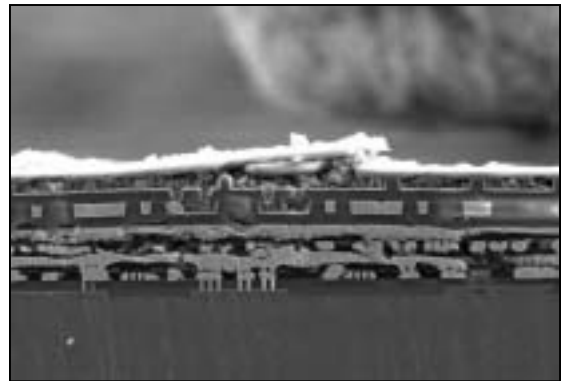
Figure 11: SEM cross-sectional image of shorting site identified in fig.'s 7-10.

Optical examination of the frontside of the chip, after removal from the substrate, identified a defect located at the center of the four-lobed peak highlighted by SSM, and also between the two lobes of the STM signal therein, as seen in Figure 10 (after the images were aligned and scaled using CAD data having features common to all three). A SEM cross-sectional image, seen in Figure 11, confirms considerable damage and short-circuiting underneath the defect site consistent with the concentrated magnetic field indicated by SSM and the strong thermal gradient measured by STM.
