Failure Analysis of Short Faults on Advanced Wire-bond and Flip-chip Packages with Scanning SQUID Microscopy

Steve K. Hsiung, Kevan V. Tan, Andrew J. Komrowski, Daniel J. D. Sullivan
LSI Logic Corporation, 3098 West Warren Avenue, Fremont, California 94539
Tel: 408-433-8838 Fax: 408-433-8892 Email: stevehs@lsil.com

Abstract

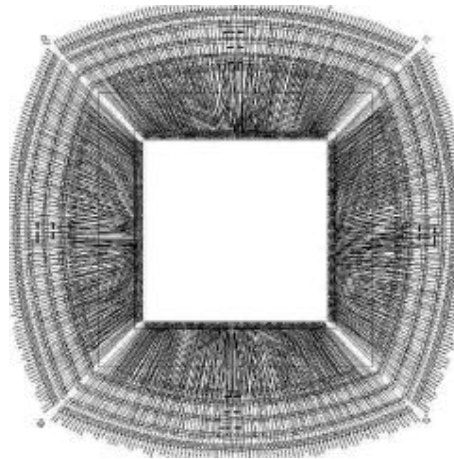
Figure 6 CAD file of the bonding diagram

The device was then analyzed by SSM. The SSM current density image (Figure 4) and current peak image (Figure 5) were obtained. The current density image was then overlaid to the bonding diagram (Figure 6). The short is on the die side (Figure 7).

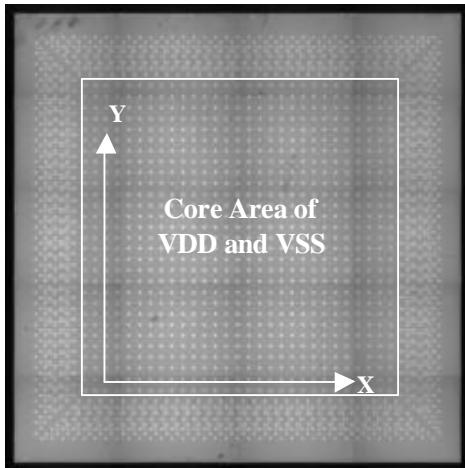
Until recently, localizing power short fault in the core area of LSI Logic's flip-chip packages with non-destructive methods was challenging. TDR analysis does not apply for power shorts. The most common technique was to separate the die from the substrate and perform random inspection through parallel-lap of the substrate. Given the large area of the power core (Figure 13), most of the time searching without localization was in vain.

Figure 13 IR image of a core area of VDD and VSS where X-Y position is marked

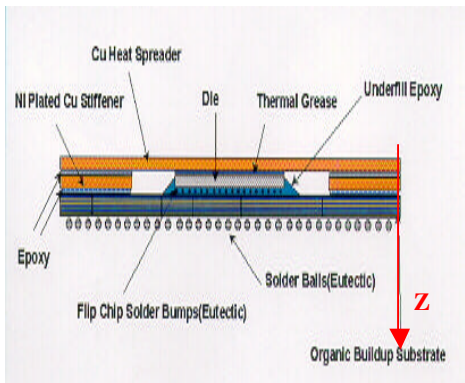
With SSM analysis it is possible to localize the X-Y position of short faults in the core. More importantly, Z position information is available. This makes possible distinguishing shorts in the interconnect solder bumps from shorts in the package substrate (Figure 14).

Figure 14 Schematic of Z position of die, interconnect solder bumps and substrate in flip-chip packages

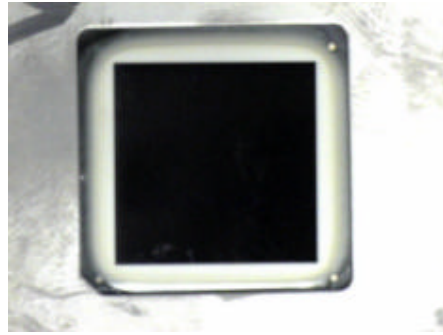
For flip-chip packages, the bulk silicon needs to be thinned down to about 100 μm . The die backside surface is polished and covered by an anti-reflective coating material to obtain better infrared images (Figure 15).

Figure 15 Optical image of a die backside after the die is thinned down to 100 μm and the die backside surface is covered by an anti-reflective coating material
